Ford C-MAX Standard Safety Equipment

Tested Model	Ford Grand C-MAX 1.5 diesel 'Titanium', LHD
Body Type	- 5 door MPV
Year Of Publication	2017
Kerb Weight	1606kg
VIN From Which Rating Applies	- WF0WXXGCEWHE77742
Class	Small MPV

Euro NCAP © Ford C-MAX Dec 2017 3/11

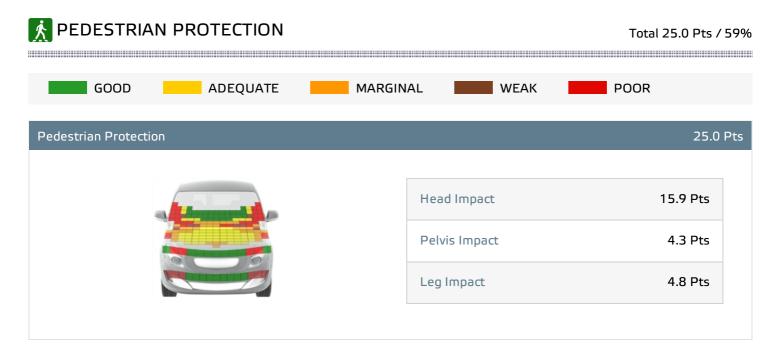
The protection provided to the head of a struck pedestrian was predominantly adequate or marginal. Protection of pedestrians' legs by the bumper was mostly good but weak in places, and that of the pelvis was also generally good but with some poor results.
